Manhole Inspection Summary

Manhole # S61M__001MH

Insp Date: **7/8/08 12:11 PM**

Location Address: **rear 922 s ponca st**

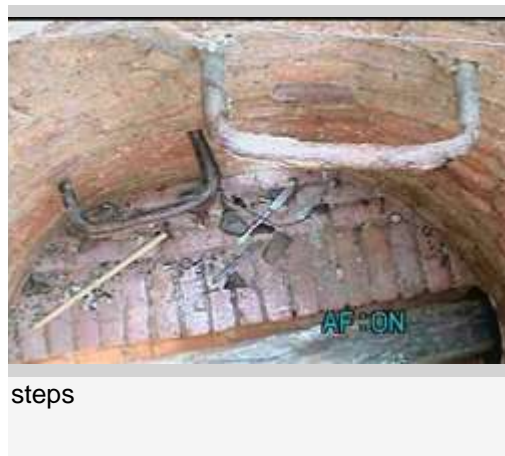
Defect 3

Steps Count: **2** Missing: **0** ☒ **Corroded**

bench debris

steps

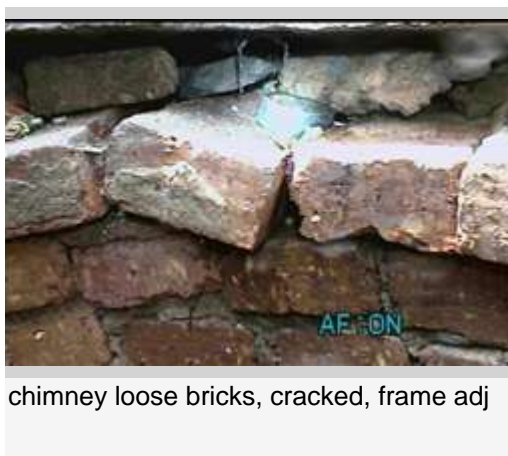
Defect 1

Condition: ☐ Sound ☒ **Cracked** ☐ Root Intrusion ☒ **Loose Brick** ☐ Deteriorated

chimney loose bricks, cracked, frame adj

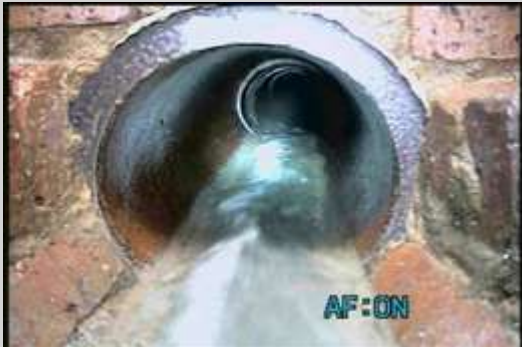
12 O'Clock Outflow

8 in. Circular Gravity Sewer
Pipe Out @ 12 O'Clock

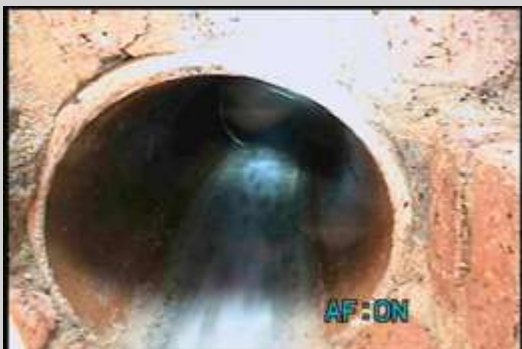
6 O'Clock Inflow

8 in. Circular Gravity Sewer
Pipe In @ 6 O'Clock
